INSPECTION REPORT PREPARED FOR:
Gary Goodman

PROPERTY:
85 Old Lisbon Rd
Topsham ME

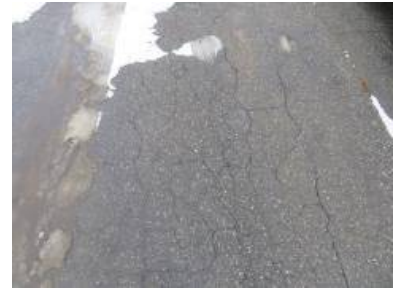
Attention Required - Observation: DRIVEWAY CRACKS - the surface of the driveway has cracks. The driveway appears otherwise functional.

Analysis: Driveway maintenance has been deferred and exposure to the elements is starting to deteriorate the surface. The rate of deterioration will be progressive unless the surface of the driveway is maintained and restored.

Recommendation: I advise the application of crack filling compound as maintenance. Once the surface is restored, seal coating should be applied at minimum 3 year intervals. A competent and qualified handyman or contractor can perform this task.

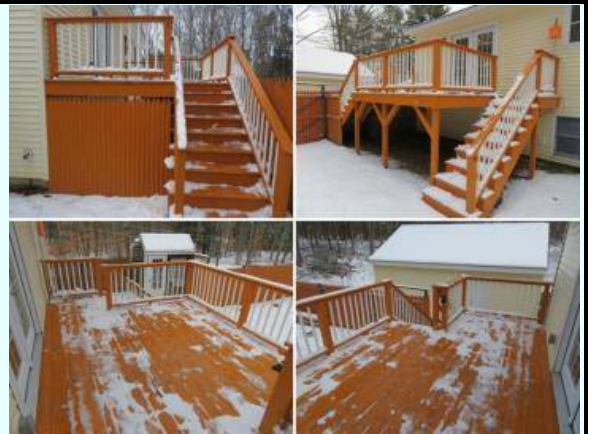
Comments: Deck condition is satisfactory and functioning as intended.

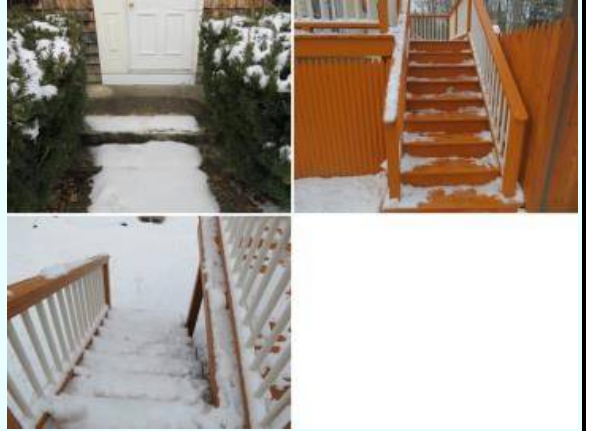
Comments: Exterior steps are in satisfactory condition and functioning as intended.

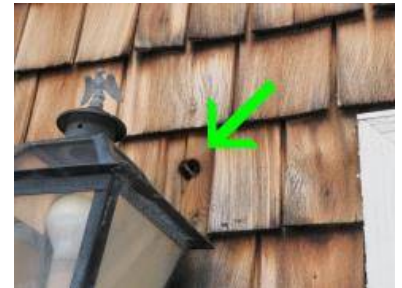
Analysis: All utility holes (such as pipe & wire holes) through the siding should be sealed to prevent heat loss, drafts, insect access and rodent entry. Maintenance repair is needed.

Recommendation: Caulk or seal each utility hole where required. A competent and qualified handyman can perform this task.

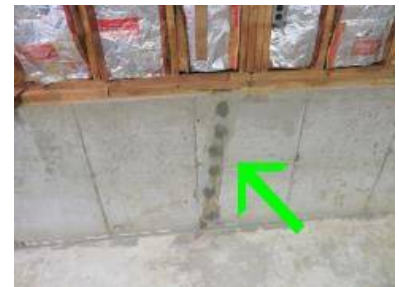
Attention Required - Observation: CRACKS NOTED - inspection of accessible portions of the foundation revealed vertical shrinkage type cracks. The one observed on the northwest wall had been patched at an unknown time.

Analysis: Shrinkage cracks usually occur shortly after construction or within the first 2 years. The cracks are caused by the introduction of excessive water during the mixing or pouring of the concrete.

Recommendation: The cracks should be monitored for water intrusion and unpredictable future movement. If elected you can hire a professional concrete repair company to fix all foundation cracks by epoxy injection with a written warranty.

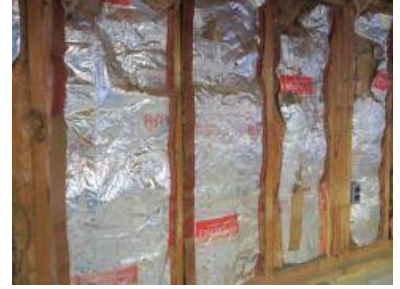
Analysis: This is a potential fire hazard. Repair is needed. Manufacturer's post the following warning and instructions:

"CAUTION: The vapor retarder facing on this product will burn and must not be left exposed. It must be covered with gypsum board or other code approved building materials. To prevent a fire, keep open flames and other sources of ignition away from the facing.

Recommendation: I advise that you install an approved covering or remove paper facing for fire safety.

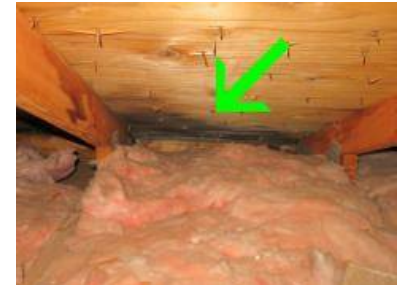
Analysis: Microbial growth is an indication of excessive moisture and/or inadequate ventilation. **NOTE: Excessive microbial growth can be an irritant to those with respiratory problems. DISCLAIMER: THE TRUE IDENTIFICATION OF microbial growth IS EXCLUDED AS BEYOND THE SCOPE OF THIS LIMITED VISUAL INSPECTION.** Be advised that the extent of microbial growth beyond visible surfaces is undetermined. Therefore, further investigation may be needed.

Recommendation: Ventilation should be improved while reducing the moisture generation source(s). If elected, you can hire a microbiology laboratory to perform a comprehensive investigation including collection and analysis of indoor air and surface mold samples, full report and discussion of qualitative and quantitative results, and suggestions concerning remediation. Be advised that testing may confirm a need to hire a professional environmental company to perform remediation at unknown expense.

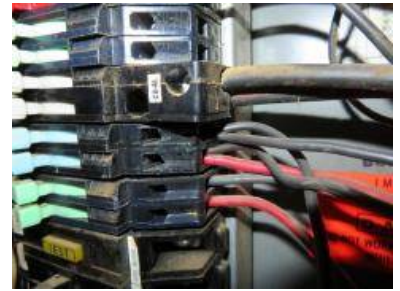
Analysis: Double tapping means that more than one circuit wire is attached to the breaker. This condition is not desirable as the double tapped breaker is more apt to trip depending on the power demand; and more importantly, a double tap is relying on the friction attachment of wires attached to a screw or clamp designed to accept one wire. Connections can come loose or cause resistance and heat. It is more desirable to have one breaker for each device connected. If there is sufficient space within the present panel box, then correction of this problem is a simple and inexpensive measure of installing another breaker and separating the wires. If the present panel has insufficient space, then room must be made by installing smaller sized breakers or by installing a sub-panel at added cost.

Recommendation: I advise that you consider hiring an electrician to perform corrections. **Note:** Some electrical inspectors allow double taps, but the practice is not considered good workmanship.

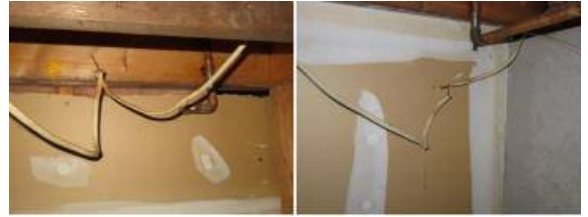
Safety Concern - Observation: AMATEUR WIRING HAZARDS - where accessible, investigation of the branch wiring in the unfinished areas of the home revealed the presence of nonprofessional alterations /handyman wiring (under stairwell). The wires tested dead at the time of inspection, but an unknown switch or breaker could make them live.

Analysis: Amateur wiring is potentially unsafe as it could pose fire or shock hazards. Because the home inspection is limited in scope and nature, every instance of handyman wiring may not be detailed in this report. Home inspections often reveal handyman wiring in such locations as basements, shops, garages and other outside locations.

Recommendation: A qualified electrician can be called to further evaluate and perform corrections as needed.

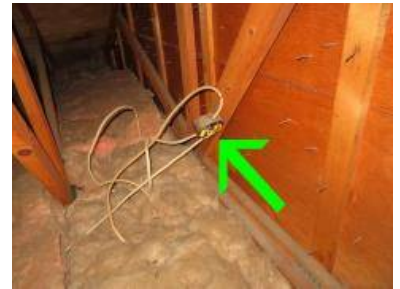
Safety Concern - Observation: COVER MISSING ON JUNCTION BOX - as observed in the attic, a cover was missing from a junction box.

Analysis: While the repair of this problem is simple and inexpensive, the missing covers create an unsafe condition that could expose an occupant to live parts where wires are joined together, and also allow for rodent entry. For safety, all wiring splices in the branch wiring should be contained inside a securely mounted and covered metal or plastic junction box.

Recommendation: All missing covers should be installed where required. A competent and qualified handyman or electrician can perform this simple repair.

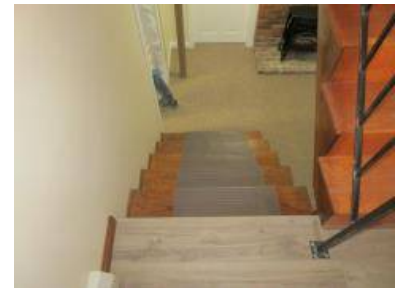
Safety Concern - Observation: INCOMPLETE HANDRAIL - the handrail at the staircase is not continuous.

Recommendation: I advise that a continuous handrail be installed as required. A qualified carpenter can be called to further evaluate and perform corrections as needed.
