INSPECTION REPORT PREPARED FOR:
Gary Goodman

PROPERTY:
85 Old Lisbon Rd
Topsham ME

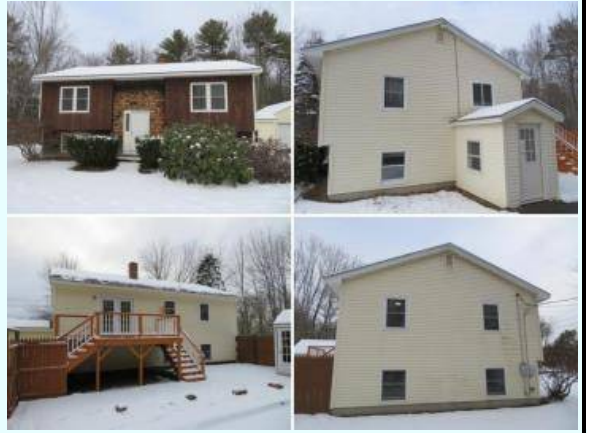
Comments: The vinyl siding is in satisfactory condition overall. Considering the age, normal wear and tear, and prolonged exposure to the weather and elements, typical deterioration and warping is noted at the wood shingle siding. Recommend monitoring the siding for eventual repair and/or replacement. Exterior structure walls are providing adequate support and appear in satisfactory condition.

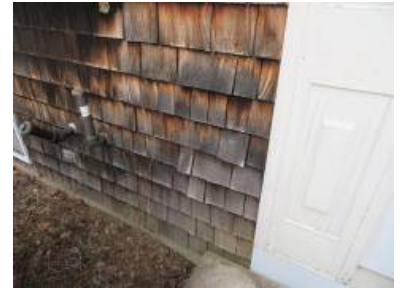
Exterior Wall Surface Materials

Attention Required - Observation: UTILITY HOLES NOT SEALED - Utility holes through the siding are not sealed (above front door light).

Analysis: All utility holes (such as pipe & wire holes) through the siding should be sealed to prevent heat loss, drafts, insect access and rodent entry. Maintenance repair is needed.

Recommendation: Caulk or seal each utility hole where required. A competent and qualified handyman can perform this task.

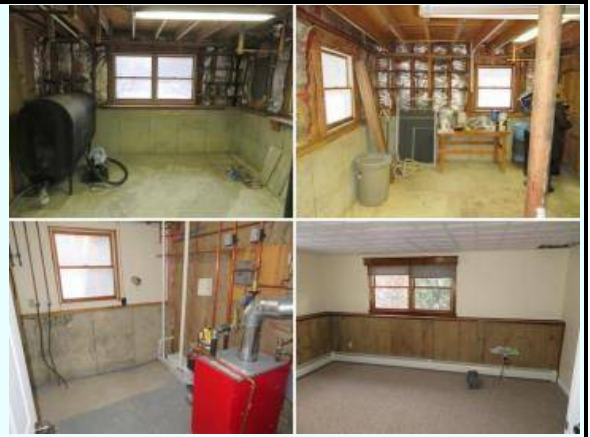
Comments: Foundation where visible is overall in satisfactory condition. Hairline cracks found in the foundation walls are typical. Floor areas accessible for walking appear to be in satisfactory condition and functioning as intended. No readily discernible problems with the floor structure can be detected on the surface of the floor coverings.

Attention Required - Observation: CRACKS NOTED - inspection of accessible portions of the foundation revealed vertical shrinkage type cracks. The one observed on the northwest wall had been patched at an unknown time.

Analysis: Shrinkage cracks usually occur shortly after construction or within the first 2 years. The cracks are caused by the introduction of excessive water during the mixing or pouring of the concrete.

Recommendation: The cracks should be monitored for water intrusion and unpredictable future movement. If elected you can hire a professional concrete repair company to fix all foundation cracks by epoxy injection with a written warranty.

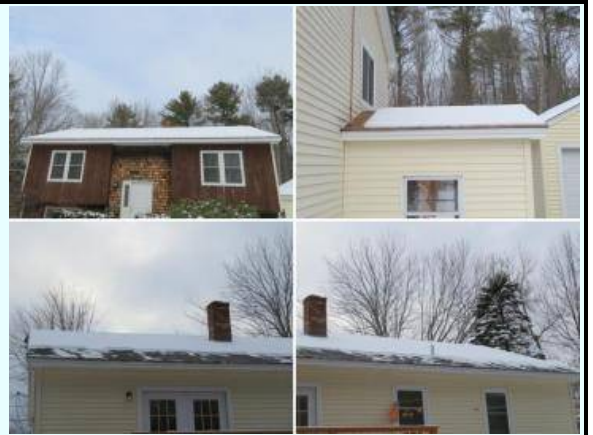
Note: The roof was covered by snow at the time of inspection and therefore was inaccessible for evaluation. The true condition of the roof covering and flashings is undetermined. Be advised that hidden defects may exist. The roof may require further research when bare of snow.

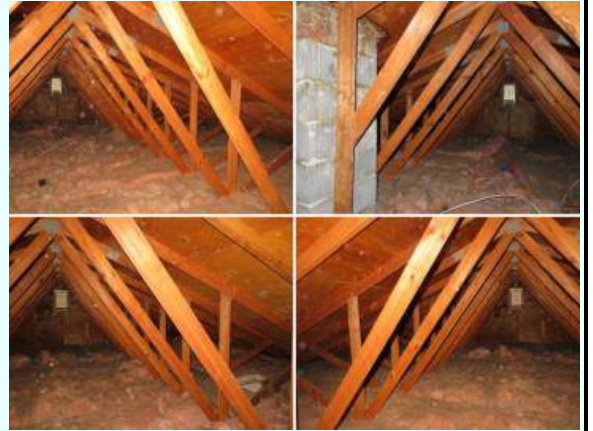
Comments: Roof structure is in satisfactory condition. Vents are in satisfactory condition except for items noted below. Water stains are observed on the under side of the roof deck near the chimney that are may have been from past roof or flashing leaks. Be advised that I was unable to fully inspect the chimney flashing due to snow cover. Insulation is in satisfactory condition except for items noted below.

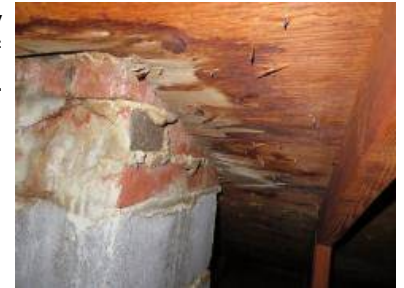
Attic

Attention Required - Observation: Suspected microbial growth was visible in areas of the attic.

Analysis: Microbial growth is an indication of excessive moisture and/or inadequate ventilation. **NOTE: Excessive microbial growth can be an irritant to those with respiratory problems. DISCLAIMER: THE TRUE IDENTIFICATION OF microbial growth IS EXCLUDED AS BEYOND THE SCOPE OF THIS LIMITED VISUAL INSPECTION.** Be advised that the extent of microbial growth beyond visible surfaces is undetermined. Therefore, further investigation may be needed.

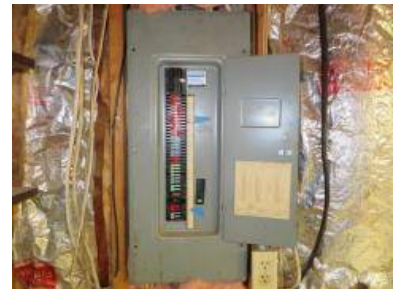
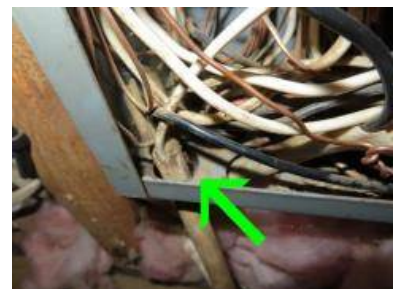
Over Current Devices

Attention Required - Observation: DOUBLE TAPS - removal of the cover on the circuit breaker panel, revealed that several of the breakers were double tapped.

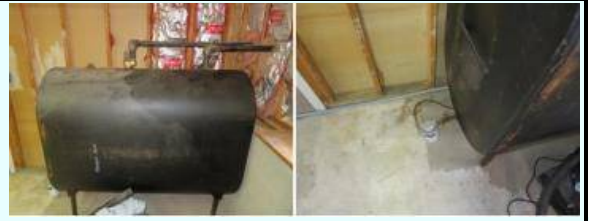
Comments: The fuel supply system is in satisfactory condition at most areas with exceptions noted below.

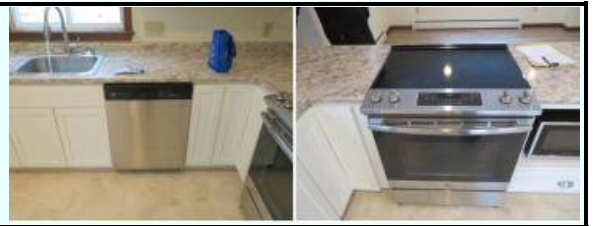
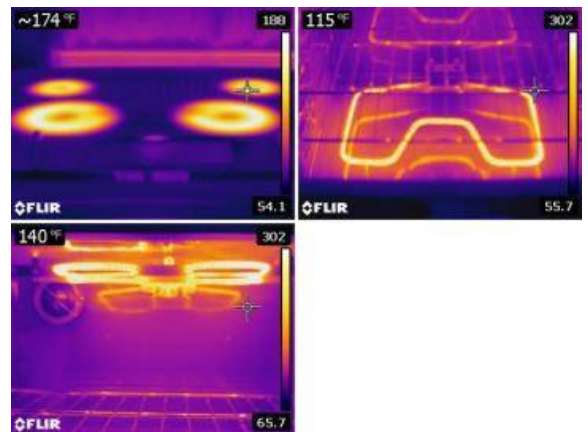
Comments: Newer appliances that are installed are in good condition and operate as intended, should provide years of service.

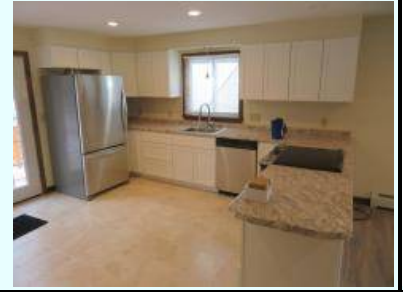
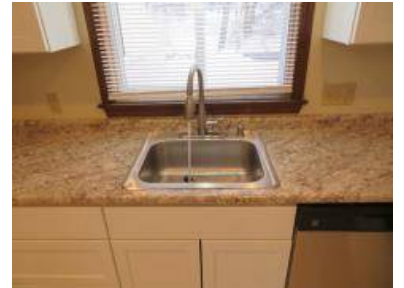
Comments: Cabinets and countertops are new, should provide years of service. Sink is in good condition.

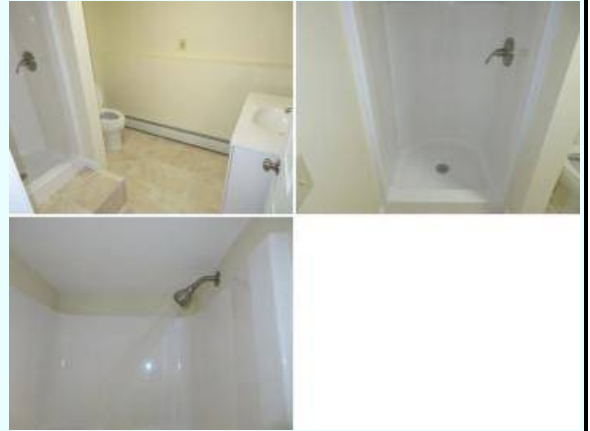
Location #2: Lower level bathroom. **Size:** 3/4 bath, there is a shower installed, no bath tub.

Comments: Overall, bathroom areas are in new condition.

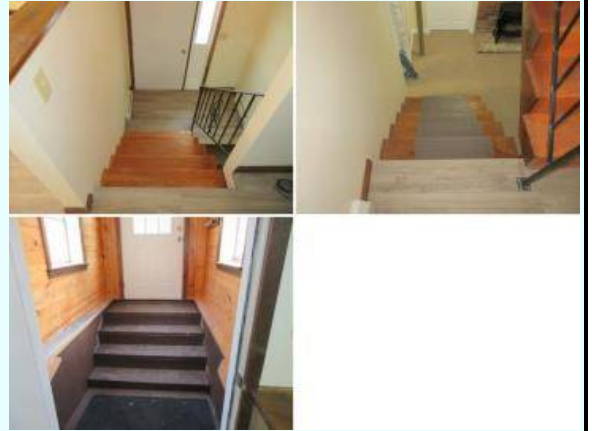
Comments: Interior stairs and related components are in satisfactory condition except for items noted below.

Analysis: This poses a safety risk as children could easily fall through the openings.

Recommendation: For safety, I recommend that a carpenter be hired reconstruct the railing components as required to reduce the size of the openings for improved safety (maximum 4 inch clearance between balusters or railing components is advised, maximum 6 inch clearance between intersection of bottom rail, tread and riser).

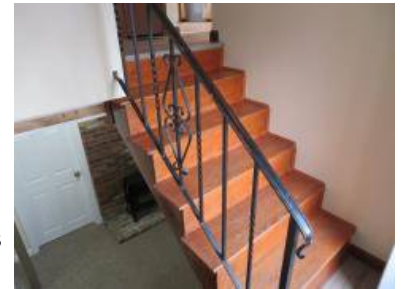
Safety Concern - Observation: INCOMPLETE HANDRAIL - the handrail at the staircase is not continuous.

Analysis: All staircases should have a continuous handrail at one side that runs the full length of the staircase for safety.

Recommendation: I advise that a continuous handrail be installed as required. A qualified carpenter can be called to further evaluate and perform corrections as needed.

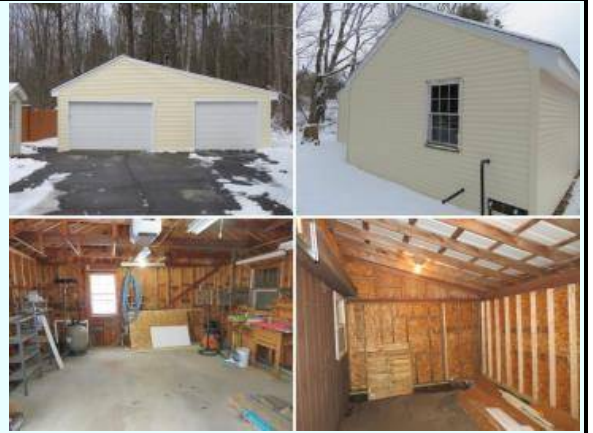
Comments: Wall structure, foundation, floor, interior wall surfaces, ceiling surface, and garage door components are in satisfactory condition with the exceptions noted below.

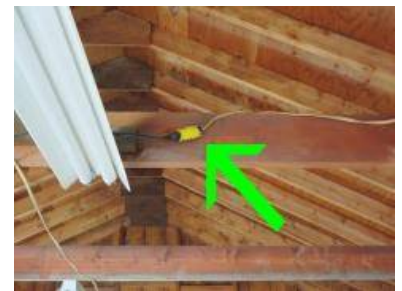
Analysis: Amateur installation. Extension cords are not designed for permanent use

Recommendation: I advise that you hire an electrician to install a local dedicated outlet for the door opener.

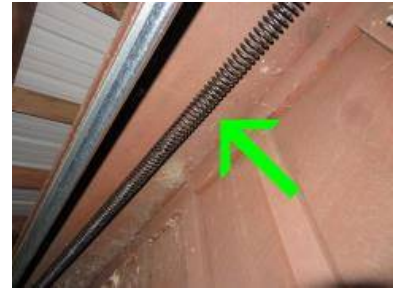
Safety Concern - Observation: NO SPRING CONTAINMENT - The springs that provide counterbalance for one of the garage overhead doors lack "spring containment."

Analysis: While the lack of spring containment may be typical of many older garage door installations, springs wear out and break overtime with normal usage. Be advised that the springs are under tension, that a broken spring can cause serious personal injury as parts can fly through the air and that operating a door with a broken spring is unsafe. Counterbalance springs and their attachment components should be restrained either externally (via a tube that contains spring[s] or internally (via a cable or shaft). Upgrading is needed.

Recommendation: I advise that you ask an overhead door contractor to further evaluate the overhead door installation and to provide a cost estimate for safety improvements.

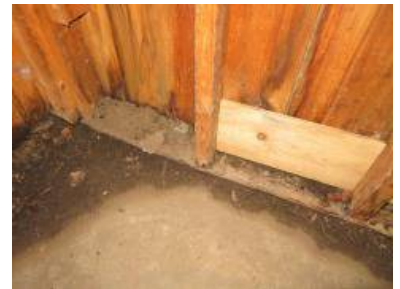
Attention Required - Observation: GARAGE SILL DECAYED - probing & sounding of the accessible portions of the garage sill revealed areas of decay.

Analysis: The drainage from the driveway appears to be directed towards the garage. Years of exposure and low ground clearance has resulted in the decay. The sill is a very important part of the wall frame that helps transfer the roof load to the foundation. Repair is needed.

Recommendation: A qualified contractor should be called to further evaluate and perform sill corrections as needed. You may elect to consult with a driveway contractor to discuss options for drainage and diverting water away from the garage.

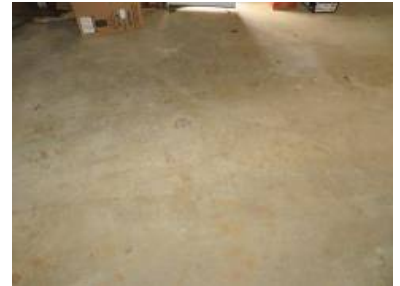
Attention Required - Observation: GARAGE FLOOR CRACKS - where accessible, the garage concrete floor has visible random cracks.

Analysis: In my opinion, these cracks are not of great significance and do not detract from the over-all condition of the garage foundation. The cracks appear to be shrinkage type cracks related to the drying process of the concrete and perhaps a lack of reinforcing wire.

Recommendation: I advise that the cracks be patched with a suitable filler to prevent further deterioration.

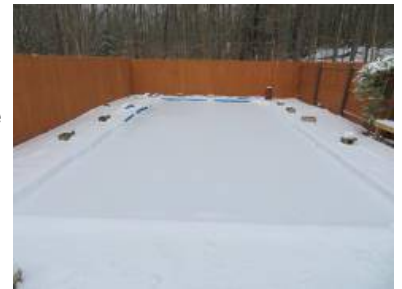
Pool Type: In ground.

Note: There is a swimming pool on the property. Be advised that the inspection of swimming pools, attached mechanical systems, decks, pool houses, pool patio and ancillary equipment are expressly **EXCLUDED** from this inspection report per contract. Be advised that pool evaluation is undetermined as much of the piping and structure are hidden from view or the pool may be closed for the season. For safety, all pools should be protected by a five foot high fence with self-closing and self-latching gate hardware. Associated electrical equipment should have modern GFCI shock protection. You should review all data and maintenance requirements with the owner prior to purchase. Other options include hiring a local pool company to perform further inspections and provide a written summary of findings prior to commitment.
